The Process of Designing and Troubleshooting a Robotic Arm

TNG 210

Abstract

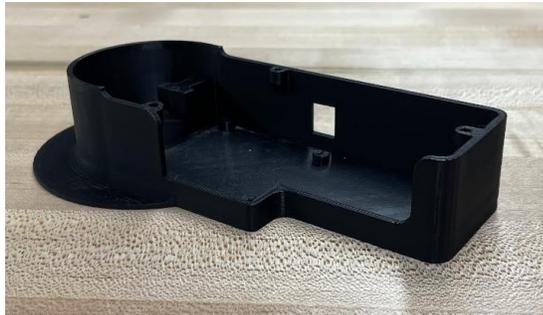
Base: PLA printed Base part

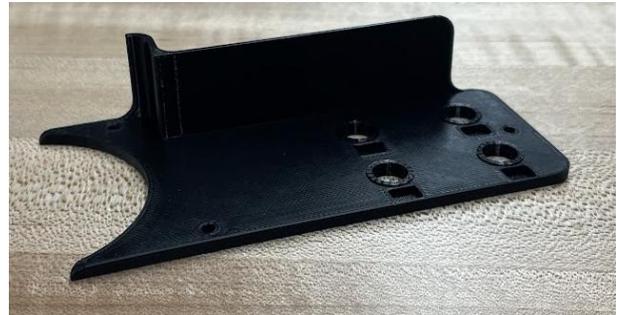
Cover: PLA printed Cover part

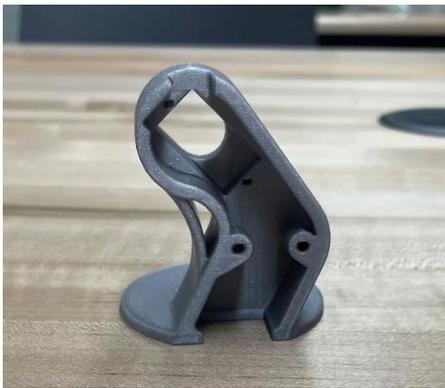
Central Axis: PLA printed Central Axis part

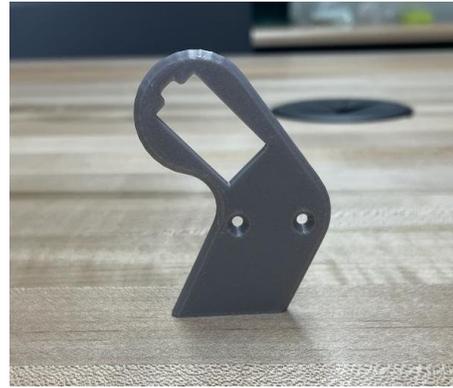
Axis Cover: PLA printed Axis Cover Part

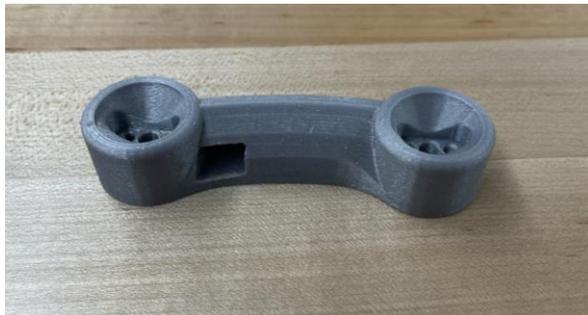
Forearm: PLA printed Forearm part

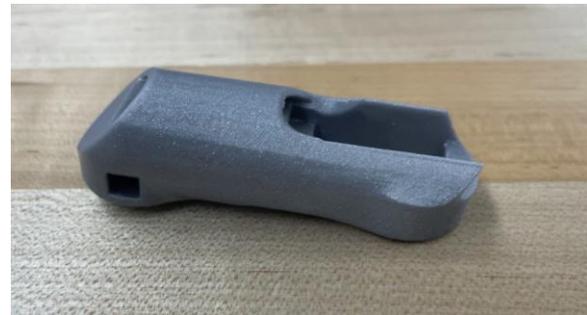
Arm: PLA printed Forearm Part

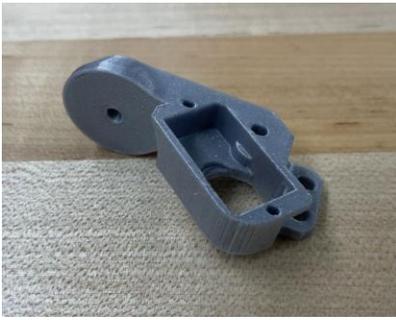
Claw Base: PLA printed Claw Base part

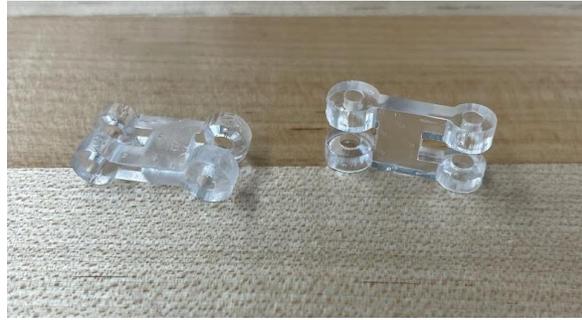
Claw Bar: Two resin printed Claw Bar parts

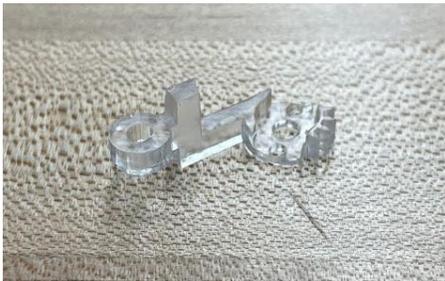
Gear 1: Resin printed Gear 1 part

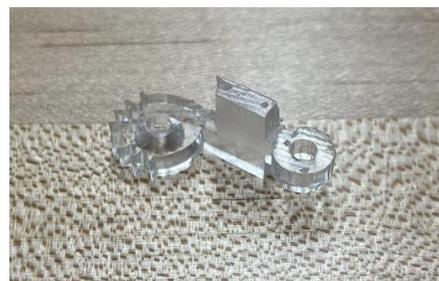
Gear 2: Resin printed Gear 2 part

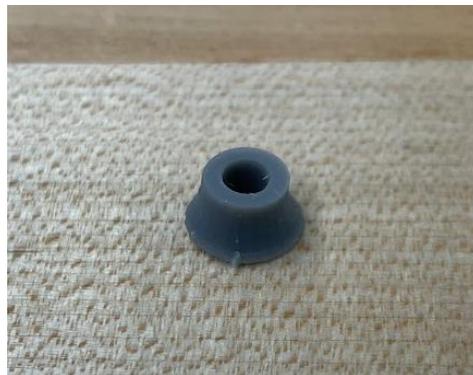
Rubber Band Mount: Resin printed Rubber Band Mount part

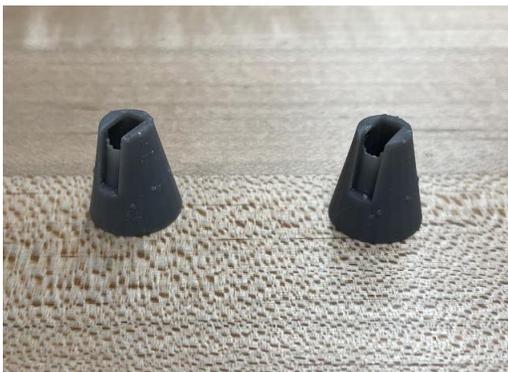
Knob: Two resin printed Knob parts

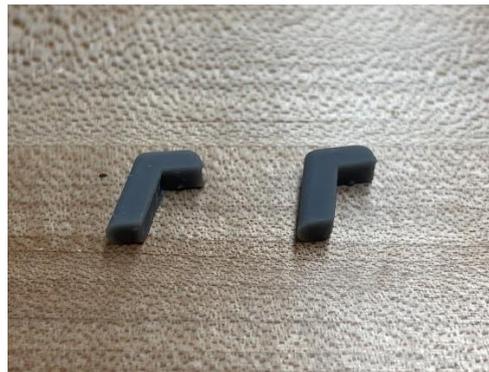
Knob Insert: Two resin printed Knob Insert parts

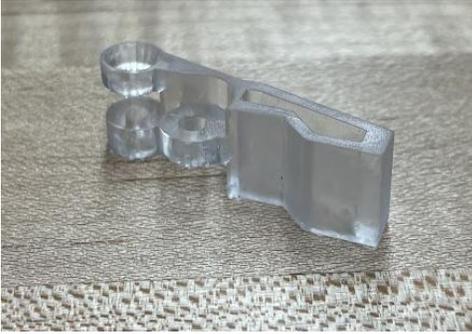
Claw 1: Resin printed Claw 1 part

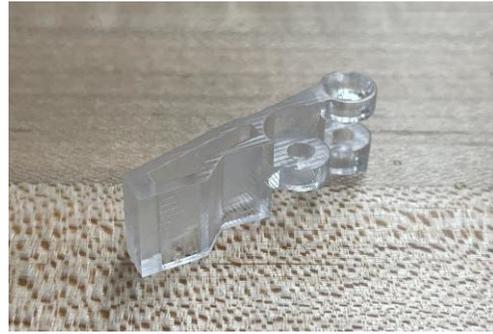
Claw 2: Resin printed Claw 2 part

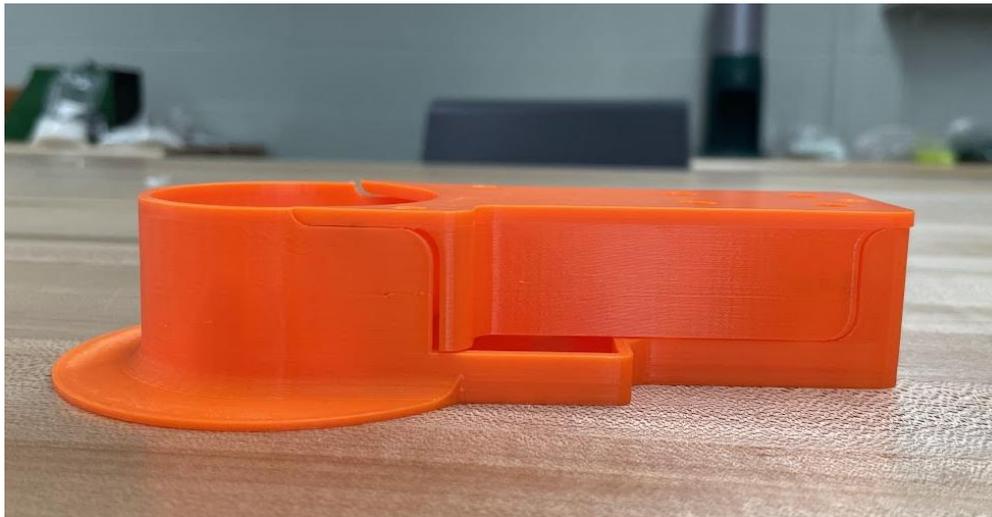
Figure 2: Improper fit between the Base and Base Cover

When designing the Base, Base Cover, Central Axis, and Axis Cover, multiple tools were used. Provided part drawings and calipers were used to find correct dimensions of the parts. The parts were then designed in Siemens NX. Multiple iterations of parts were created during the design process. The largest improvements were the mounting holes and connecting points between the Base and Base Cover to ensure a proper fit. Figures 1-4 show the before and after of these iterations. Also, the Central Axis was put through many iterations due to printing failures, seen in Figure 5. To find the location of the printing failure, the printing process was watched and stopped once the layer shifting occurred. The Central Axis needed a complete redesign before it would successfully print. Once the Central Axis was completed, it was copied and edited to make the Axis Cover, ensuring a perfect fit between the two parts. The team was provided with .STL files for the Arm, Forearm, Claw Base, Claw Bar, Gear 1, Gear 2, Rubber Band Mount, Knob, Knob Insert, Claw 1, and Claw 2. All the parts that were printed with PLA were sliced with Prusa Slicer. In Prusa Slicer, the team had to ensure the part was oriented to have a flat side against the build plate, otherwise the print would fail. Some parts required organic support to be generated. All the PLA parts were printed on Prusa 3D printers, and can be seen in PrusaSlicer in Figure 6. Some parts, determined by the team for quality and aesthetic purposes, were printed with resin. Resin prints had better quality gears and could be printed in clear or gray resin. These parts were sliced on Preform. In Preform, the team was able to utilize auto orienting and auto generating support features to ensure the prints were good quality. The resin prints were printed on Formlabs resin printers. The resin prints were post-processed in Formlabs washing and curing stations. For all parts, quality was checked and if the print had supporting materials, they were removed with needle nose pliers and diagonal cutting pliers. A Base Cover part that was printed with clear resin can be seen in Figure 7. The team also experimented with injection molding the Axis Cover. The molds were designed in Fusion and then sliced on Formlabs and printed with resin. The molds were then washed and cured and the plastic was injected. During the process, the mold cracked due to

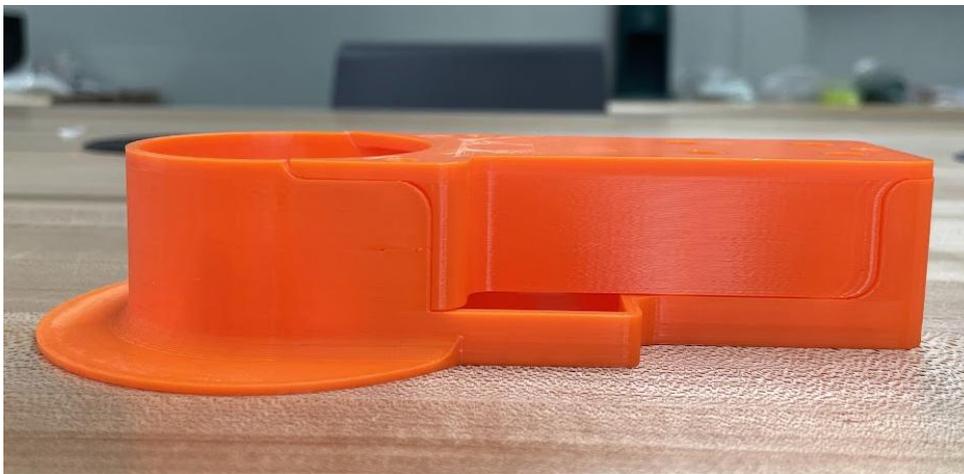
Figure 4: Proper fit between the Base and Base Cover

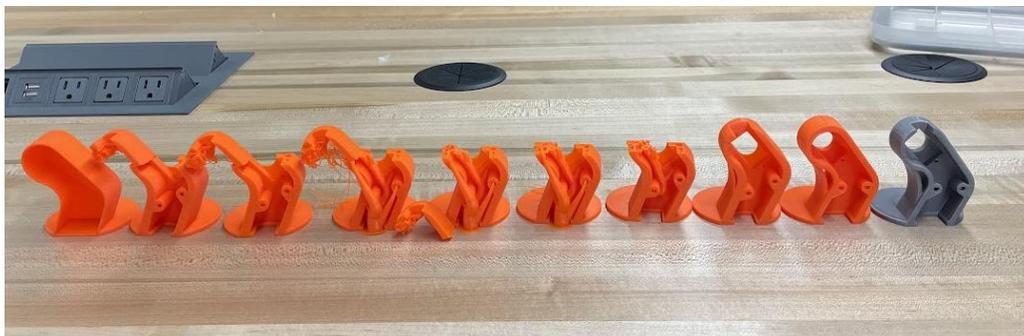
Figure 5: All iterations of Central Axis

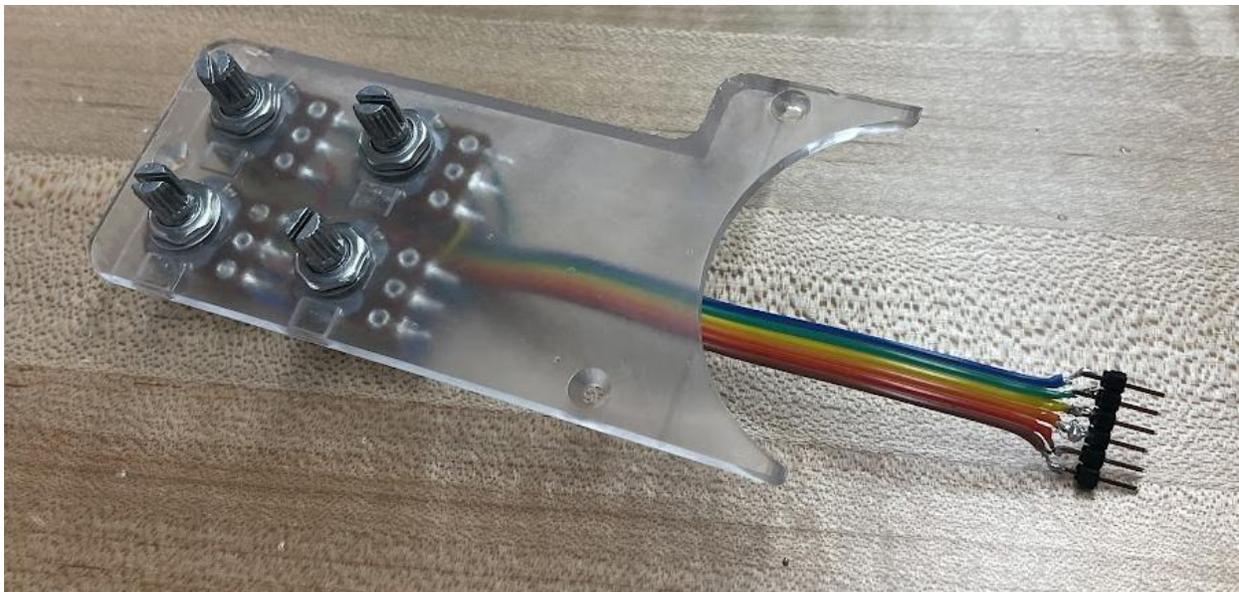
Figure 7: Base Cover printed in clear resin with the potentiometers and ribbon cable attached

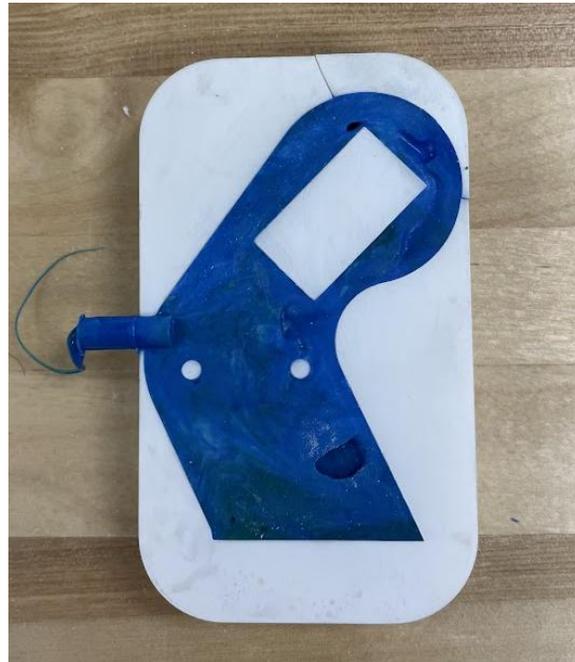
Figure 8: Injection mold and part. There is a visible crack on the top right side of the mold

some warping that occurred during the curing process. It was also very difficult to remove the part from the mold, so to avoid damaging both the part and the mold any further, the part was kept in the mold. The part and the mold can be seen in Figure 8.

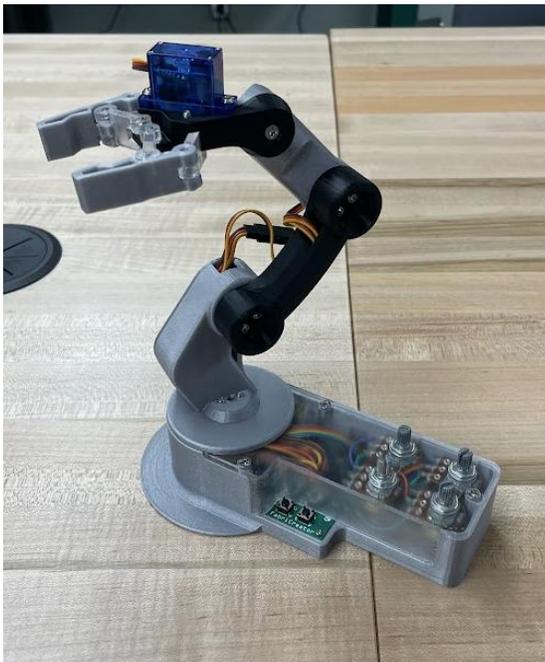
Figure 9: Jake's Robotic Arm

After all the parts were printed and gathered, assembly was started. All parts were secured and installed using screws. First, the circuit board and the first servo were installed into the Base. The Arduino was placed into the female heads of the circuit board. Next, assembly moves onto the Central Axis. A servo bracket had to be cut to fit into the bottom of the Central Axis and was screwed in, and another servo and servo bracket were installed into the top of the Central Axis. The servo bracket was then connected to the Forearm with screws. Assembly then moved onto the claw section. A servo and servo bracket were installed into the Claw Base. Gear 1 was installed onto the servo bracket, and Gear 2 was installed next to Gear 1 on the Claw Base. It was important to make sure both Gear parts moved together to the front and back positions and had full range of motion. If they didn't have full range of motion, the gear teeth weren't lined up correctly and they had to be adjusted. Next, the Claw Bars were installed onto the Claw Base, then Claw 1 and Claw 2 were attached to their respective Gear and Claw Bar. Once the claw section was completed, it was tested again to make sure the claw could fully open and close. Next, the Claw base was attached to the Arm without a servo, so it stays in a fixed position. The servo cable attached to the Claw Base was routed through the Arm, and then the final servo and servo bracket were installed onto the Arm. The servo bracket was then connected to the open side of the Forearm. Next, all the servo cables were routed through the Arm and Central Axis. Then, the Axis Cover was installed onto the Central Axis, and the Rubber Band Mount was installed onto the Forearm, and the rubber band was put in place. Next, the servo cables had to be plugged into their respective male headers on the circuit board. To test which servo cable was connected to each servo, power was given to the power adapter, and the servos were manually checked by plugging in the Cover's 6 pin ribbon cable to the circuit board and adjusting the potentiometers to see which servo moved. Once the Cover and all the servos were plugged into the circuit board, the Cover was installed onto the Base. Finally, the Central Axis was installed onto the servo bracket on the Base. Jake's robotic arm can be seen in Figure 9, Tomas' robotic arm can be seen in Figure 10.

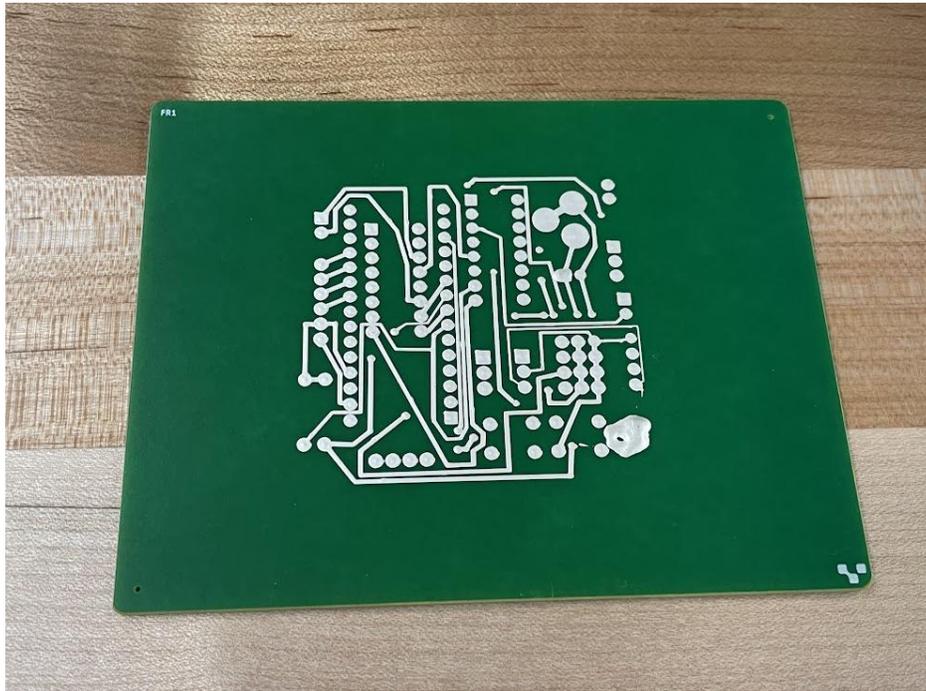
Figure 13: PCB with printed conductive ink

The team also got a chance to use PCB printing and CNC router to create a circuit board. The team used a Voltera PCB printing machine. The blank PCB was installed into the machine, and then the machine was run through its probing cycle. Then, the probe was replaced with a nozzle and printed conductive ink onto the PCB. The team noticed that the conductive ink wasn't perfectly centered on the PCB because they had to do their best to manually center it. The PCB with conductive ink is shown in Figure 13. To CNC the PCB, the team had to design the circuit board cutout in Fusion. Then, the team went through the process of using the Tormach CNC router. The CNC router cut through some of the conductive ink on the PCB because it hadn't been properly centered in the first step. The PCB was just used for practice, but the team learned how important it is to have the conductive ink centered in the future. The final PCB can be seen in Figure 14.
